# 2002 Annual Compliance Report

## Lowman, Idaho, Disposal Site

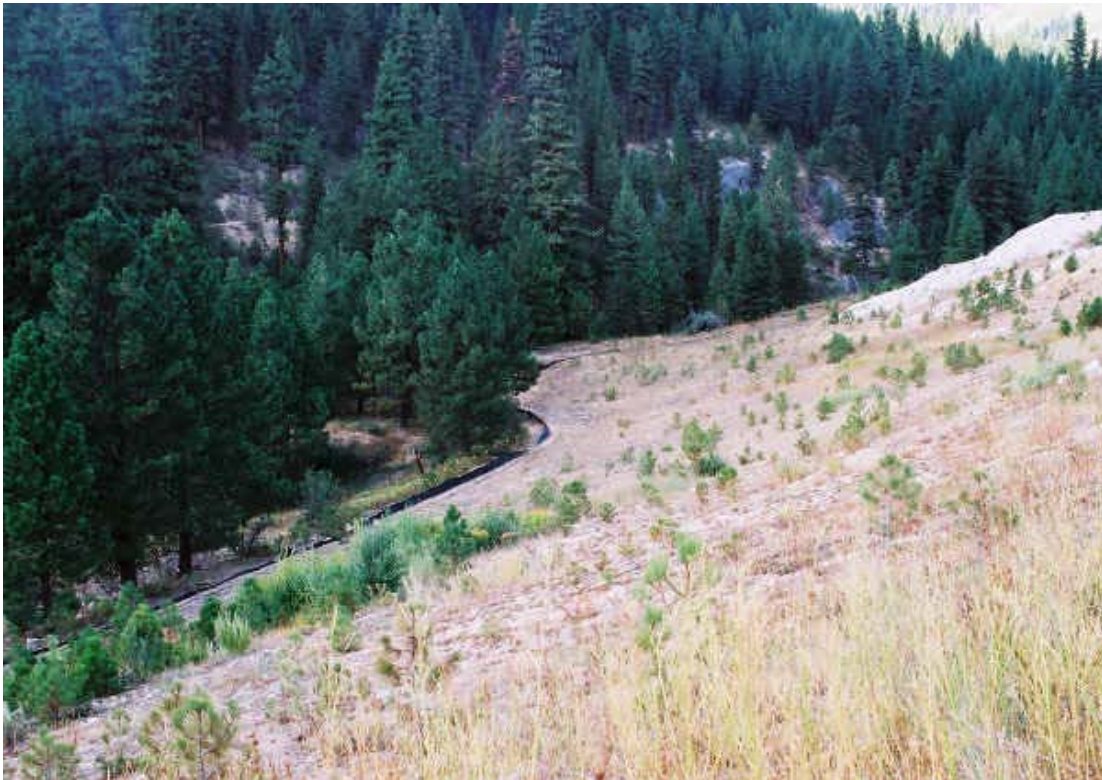
A silt fence was erected in 1998 along the west side of the erosion control project (PL-1). Vegetation has successfully established upgradient of the fence. Two erosion rills near the silt fence, one west of the granodiorite knob (PL-2) and one west of perimeter sign P3 (PL-3). These rills do not affect the integrity of the disposal cell.

*PL-1. Silt fence along the west side of the erosion control project.*

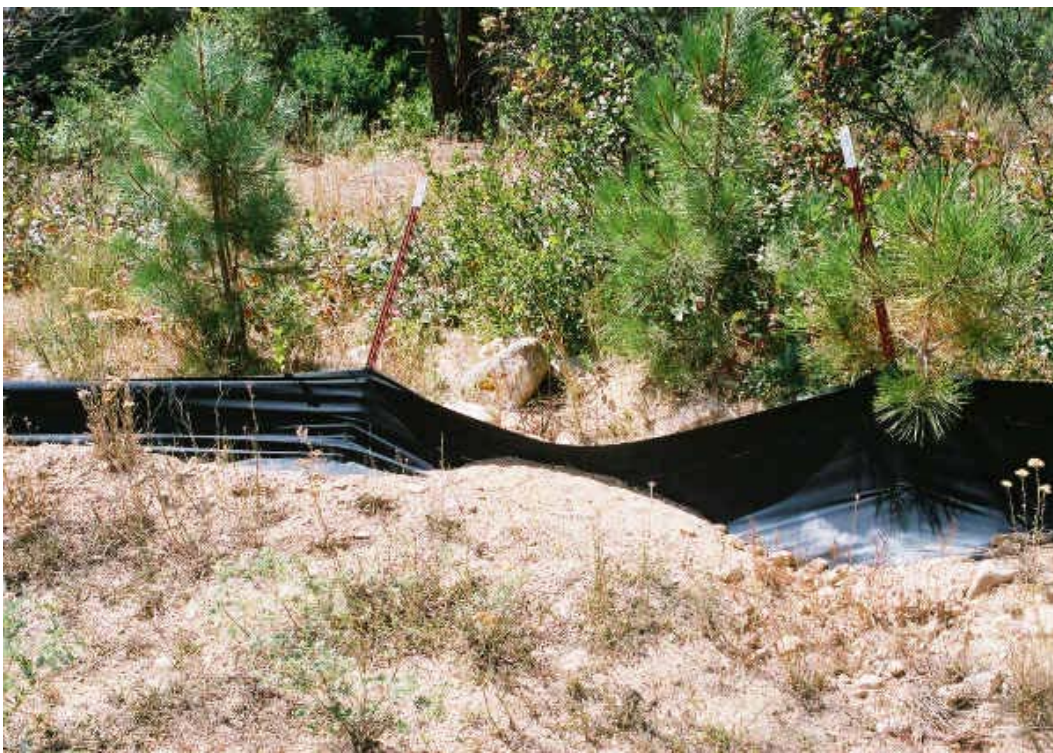
*PL-2. Erosion rill below silt fence near granodiorite knob.*

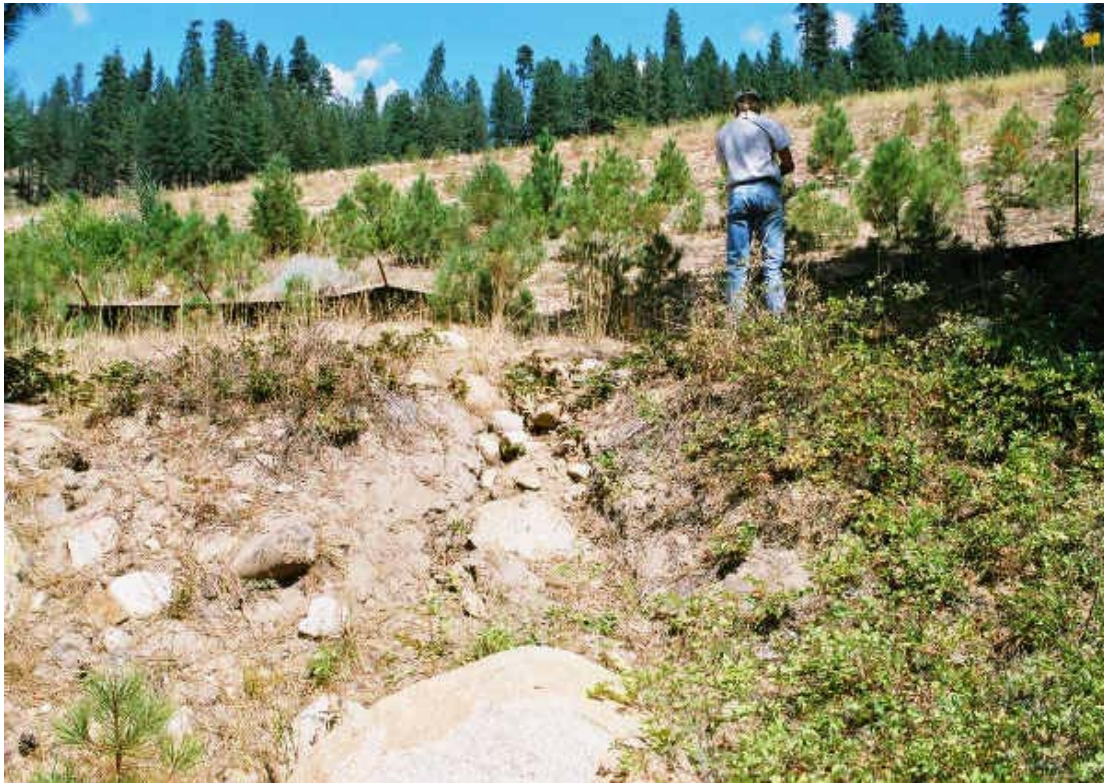
*PL-3. Erosion rill below silt fence near perimeter sign P3.*
